LANDSLIDE MAPPING AND PROCESSES IN THE GRAMPIANS, VICTORIA

Honours Research Thesis, Bachelor of Applied Science (Honours) -
Geology, University of Ballarat, Victoria, Australia

James G. Cameron

October - 2013

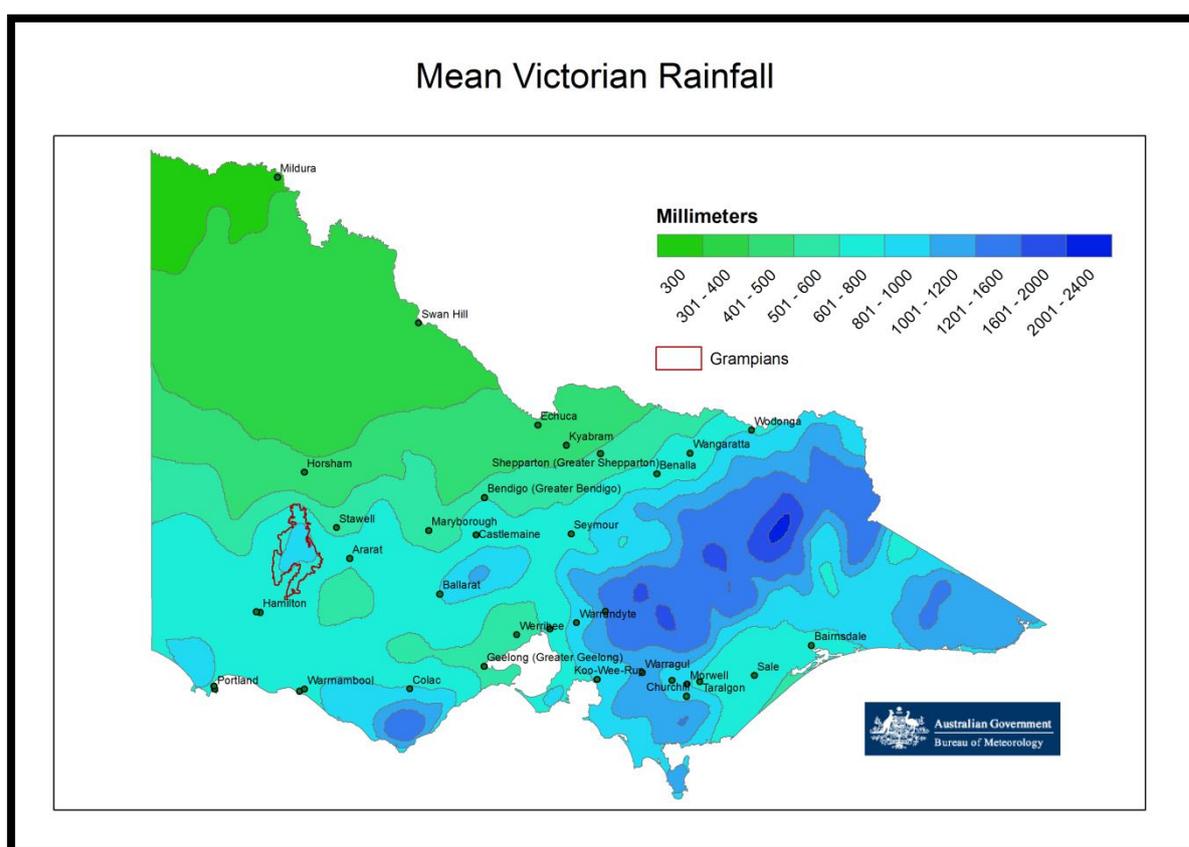
Figure 1.2 Victorian average annual rainfall (modified from BoM, 2013).

The climate of southwest Victoria is heavily influenced by the prevailing weather patterns of the Southern Ocean that characteristically progress from west to east. The weather patterns remain a constant alternation between high pressure and low pressure systems (DPI, 2013), that move southward in summer and northward in winter. The Grampians region has a temperate climate with warm dry summers and cold wet winters (BoM, 2013). The main axis of the Grampians Ranges is situated perpendicular to the prevailing weather systems, with an elevated topography that greatly contrasts to the surrounding table lands and consequently the area experiences a higher rainfall (Calder, 1987) (Figure 1.2).

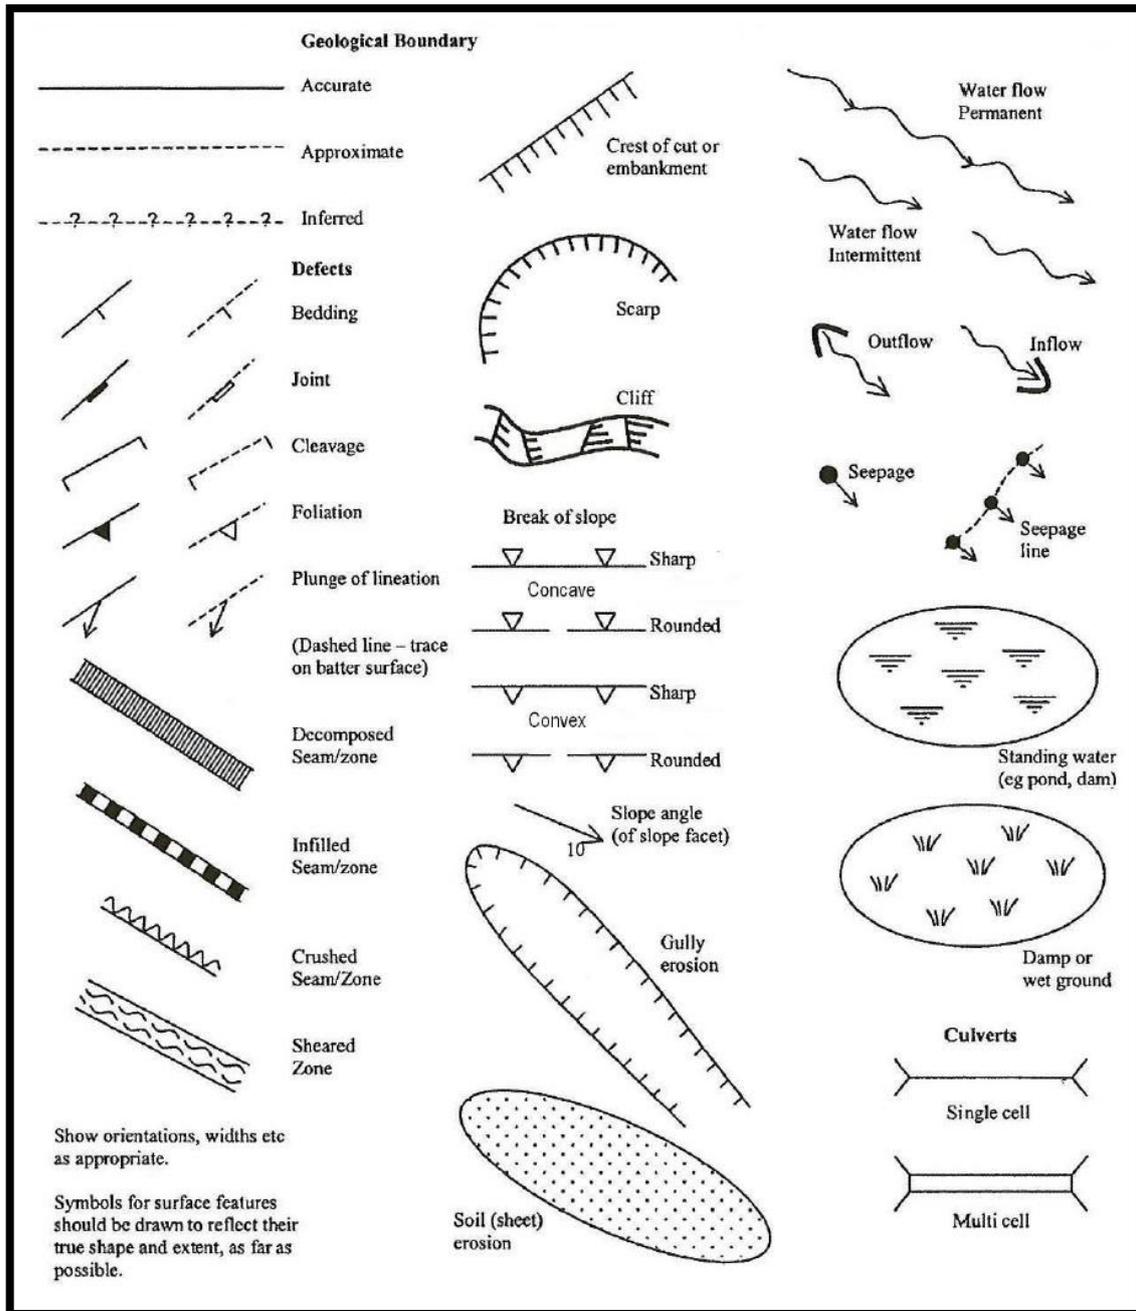
Figure 2.2: Geologic and geomorphic mapping symbols to be used during field mapping (AGS, 2007c).

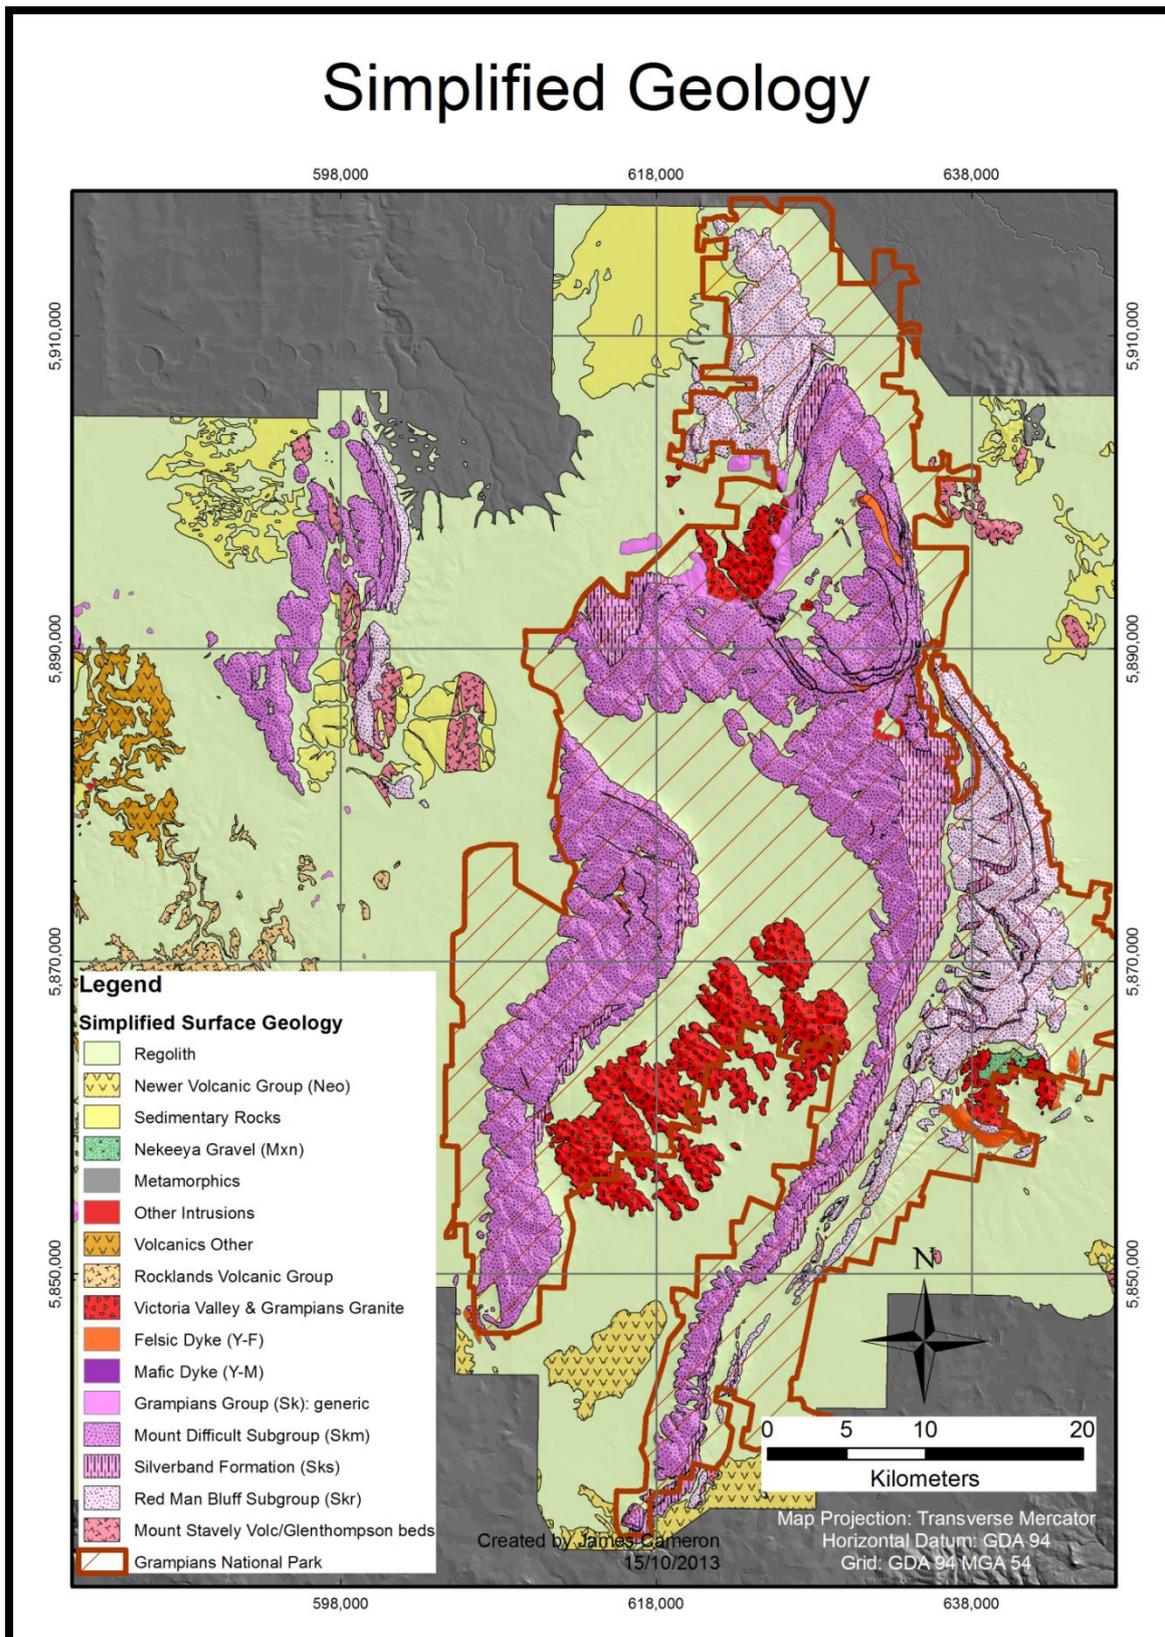
Figure 3.1 Map: Simplified Surface Geology. Colours basically represent the geologic age (light red-Cambrian, pinks –Ordovician/Silurian, dark green –Mesozoic, yellow-Tertiary, light green-Quaternary and Various igneous bodies).

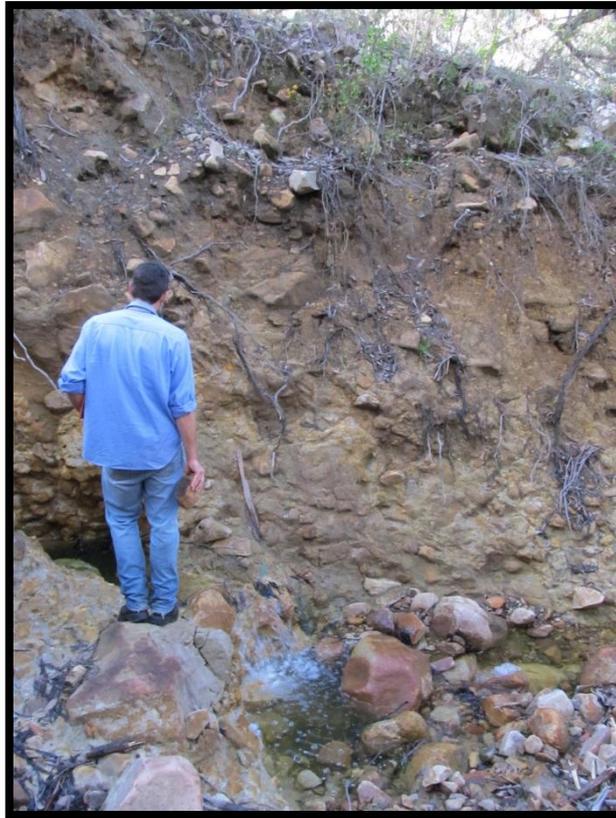
Figure 3.3 A freshly exposed profile of semi-consolidated debris on scree slopes (Debris Flow Site 5).

scree is comprised of varied angular-rounded fragments of silt to boulder sized debris which is evidence of one form or another of debris flows/landslides (figure 3.3).

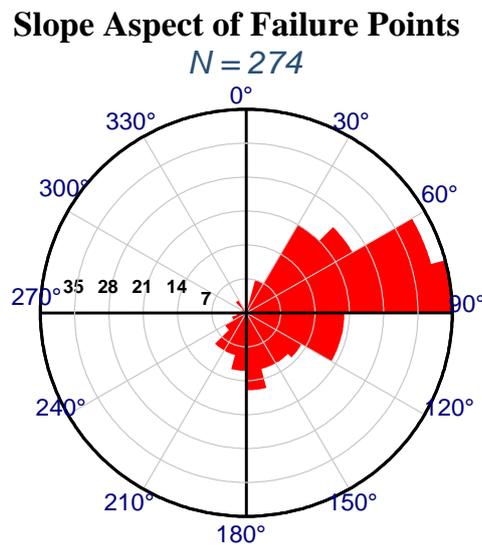
Figure 5.12 A rose diagram of the slope aspect of failure points.

Aspect - Despite an obvious correlation between slope aspect and debris flows (Figure 5.11), there was a range of slope aspects on which the flows occurred (007°-350° Azimuths) with a mean failure point direction of 113.2°. From this ambiguous information there were no clear connections so the data was better displayed as a frequency rose diagram (Figure 5.12), where frequency is measured as distance from centre and azimuth as a bearing. If the four major directions are north (315-045°), east (45-135°), south (135-225°) and west (225-315°) the eastern direction accounts for a large proportion of the failures whereas the south and north are secondary while west is almost negligible.

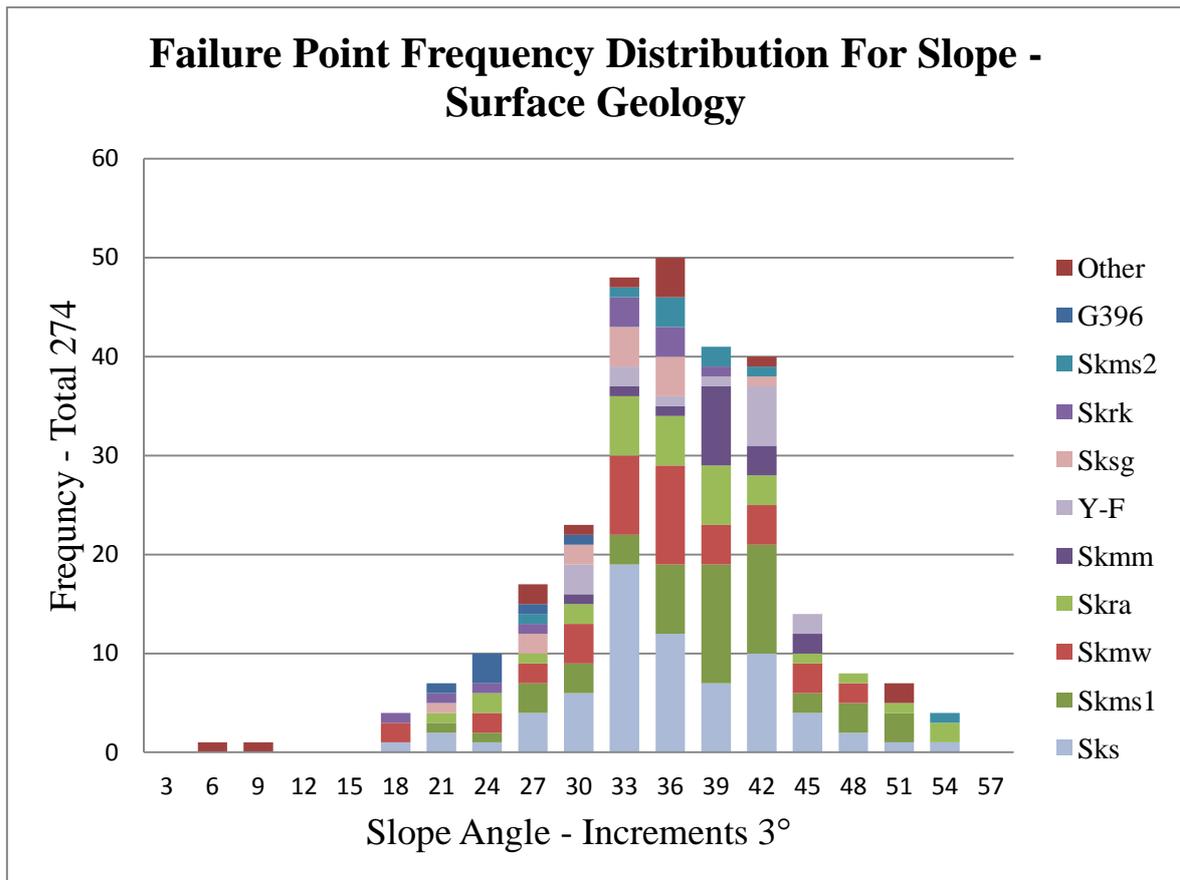
Figure 5.13 Normal frequency distribution of failure points related to slope; frequency of failures related to slope of geological units.

Slope - Perhaps a more relevant control on landslide occurrence was in fact slope angle, which is loosely connected to slope aspect as slopes of greater gradient up to 90° exist as the east facing scarps. The slope data was widely distributed, considering the maximum range is 0°-90°, between 53.3° and 5.2° and was normally distributed with a mean failure angle of 34.3° and a median of 34.7° see Figure 5.13.

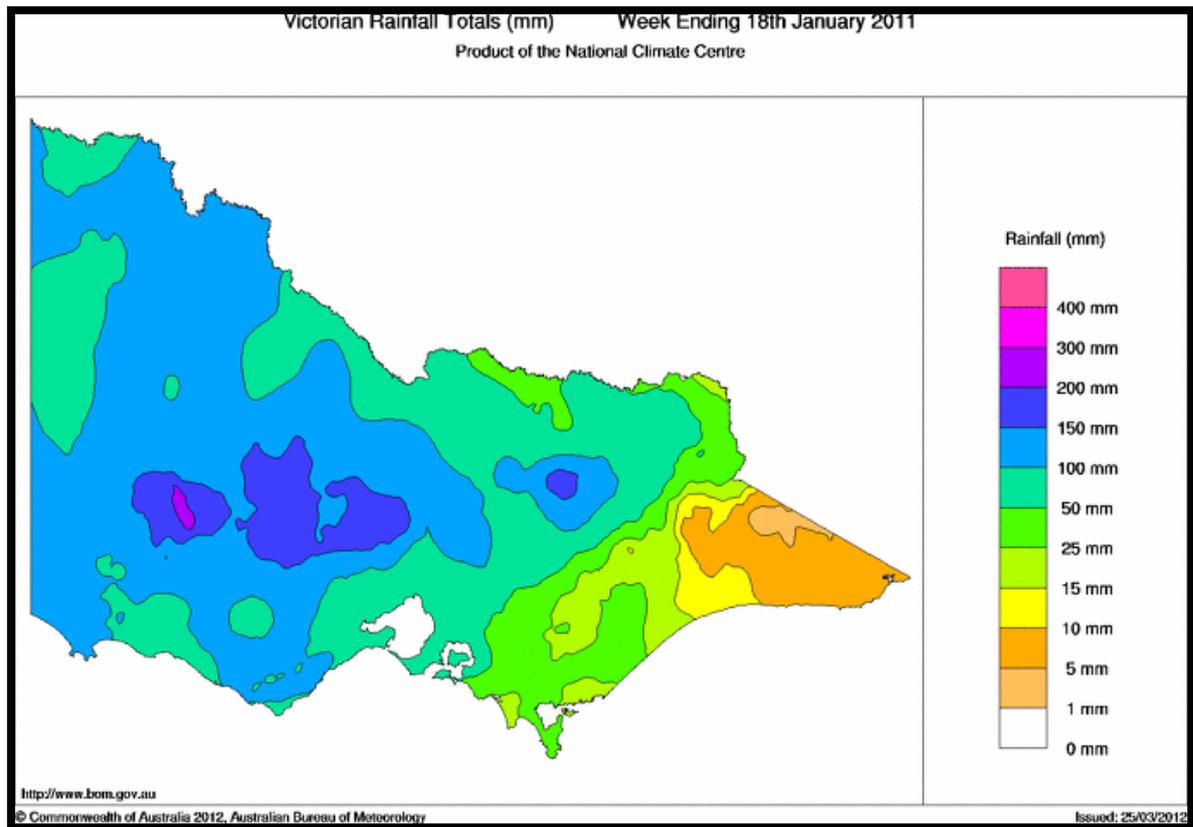
Figure 5.14 Rainfall for the week ending 18th January 2011 (BoM, 2013). Note the oblate 200mm to 300mm purple colour over Halls Gap and Mount William weather stations.

Rainfall – Rainfall can be difficult to measure due to the highly variable distribution from local and regional influences, such as topography. For this reason rainfall can only be analysed subjectively in this case. The average rainfall of the whole area including the surrounding lowlands is approximately 35mm for the month of January. However the rainfall experienced in 2011 averaged 177mm most of which fell during the 12th,13th and 14th of the month of January (BoM, 2013). Parts of the ranges experienced far greater falls of 297mm and 290mm at the Halls Gap and Mount William weather stations respectively (Figure 5.14).

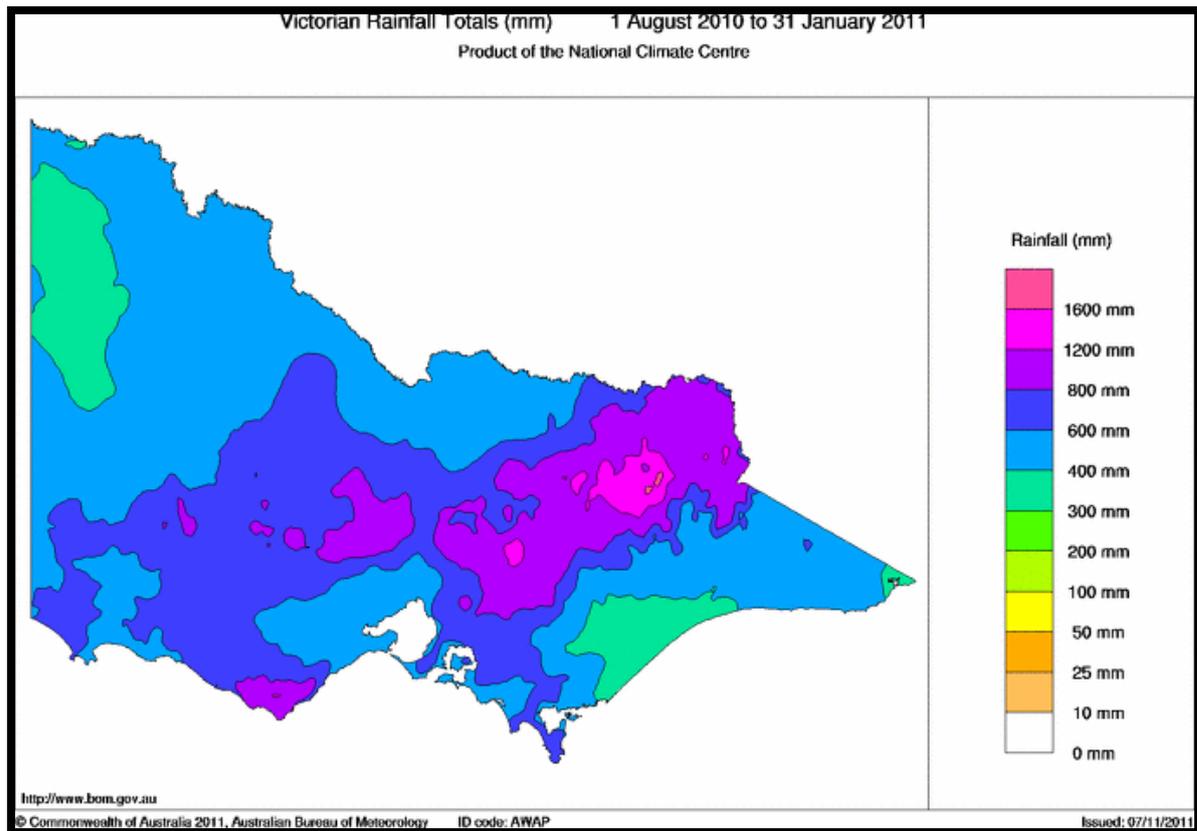
Figure 5.15 Rainfall totals for the state of Victoria to the 31st of January 2011 (BoM, 2013). The Grampians area includes the western most 800-1200mm rainfalls and surrounding dark blue areas.

An important note to make, regarding Figure 5.15, which is the six month period to the 31st of January 2011 that experienced far above average rainfall for that time, 600-1200mm when a reference to Figure 1.2 will show the annual rainfall range is equal to or less than this amount (500-800mm). All of the months in this six month period experienced greater than average rainfall often double or treble the average, such as August and December 2010 and perhaps up to six times the average during January 2011.

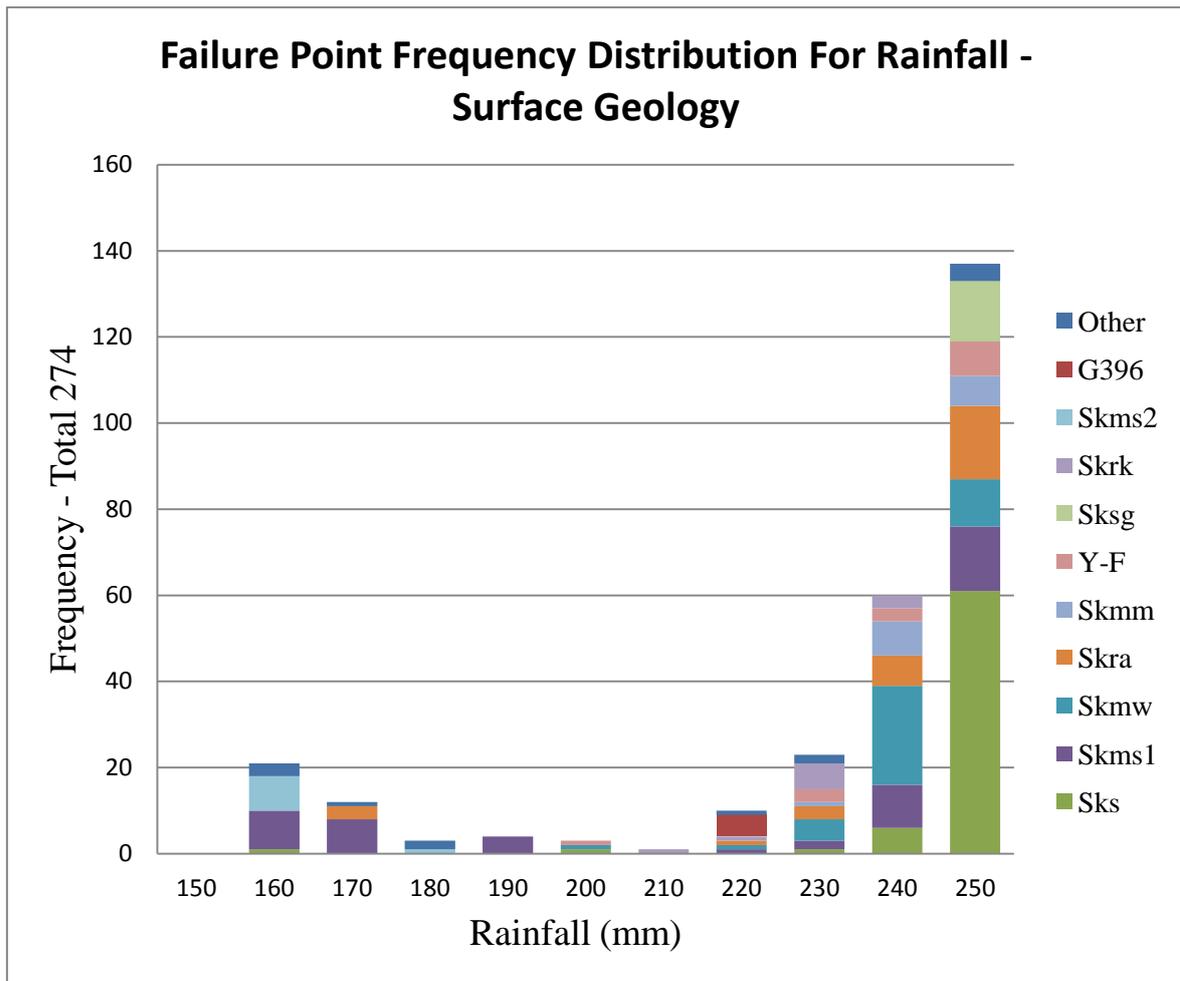
Figure 5.16 Frequency of failure points related to rainfall and geological units.

Figure 5.16 at first may appear irrelevant with no real distribution shape. The graph shows a bimodal frequency with two maximums of the lowest and highest rainfalls in the range. Nevertheless the frequency in relation to geology does show some correlation, for instance the siltstone and sandstone dominated Serra Sandstone (Skms2) more readily fails at lower rainfalls and the Glen Hills Sandstone Member (Sksg). One very clear fact is if rainfall is greater than 210mm the frequency of landslides increases exponentially.

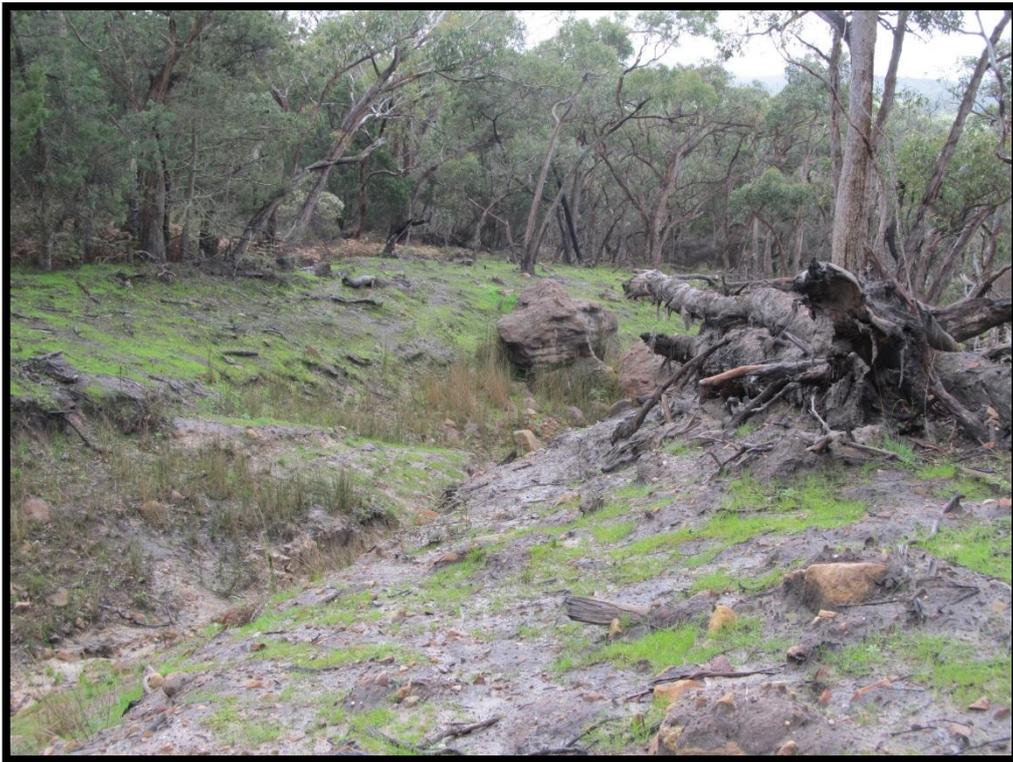
Figure 5.202 Zone B with very large boulders $\geq 2\text{m}$ some trees strewn to the peripheries.

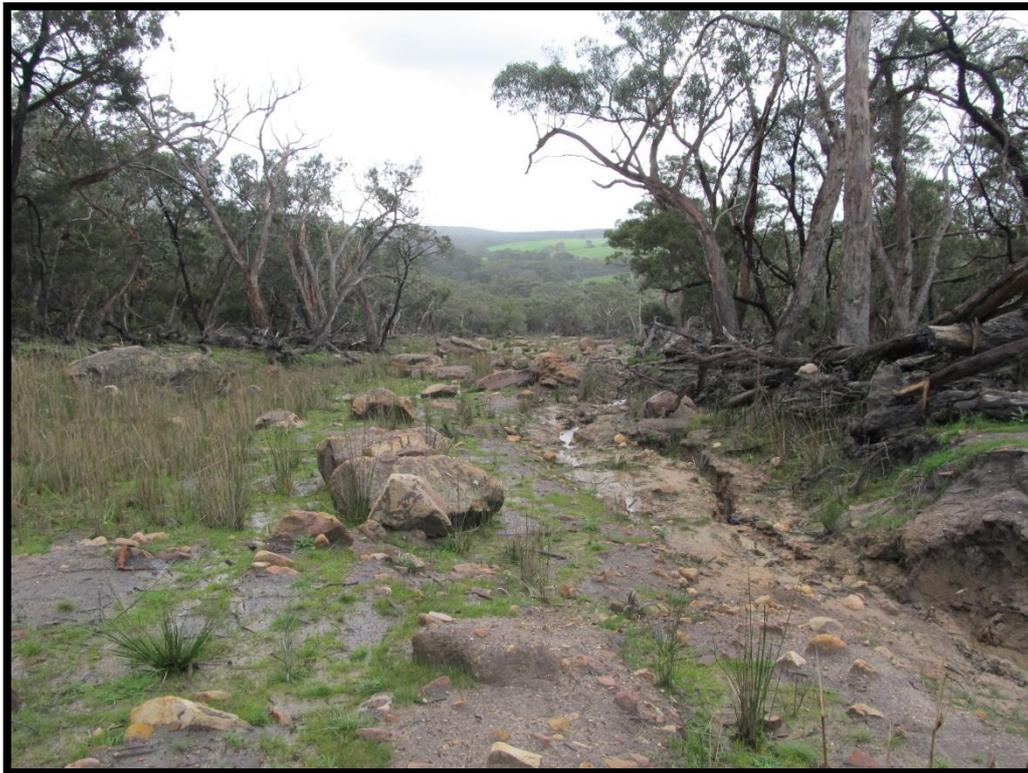
Figure 5.203 The area of transition from Zone C to Zone D Facing eastward.

Zone D – The primary zone of deposition where a large range of sizes of debris have dropped out: boulders (1.5-2m), gravel, sand, silt and trees. In this section, trees have been strewn to the edges of the flow (Figure 5.203). Figure 5.201 also shows this area to be the longest area over Silverband Formation and Sand Heathland vegetation. No downward erosion has occurred in this section; by contrast it shows characteristics of an alluvial fan, spreading out.

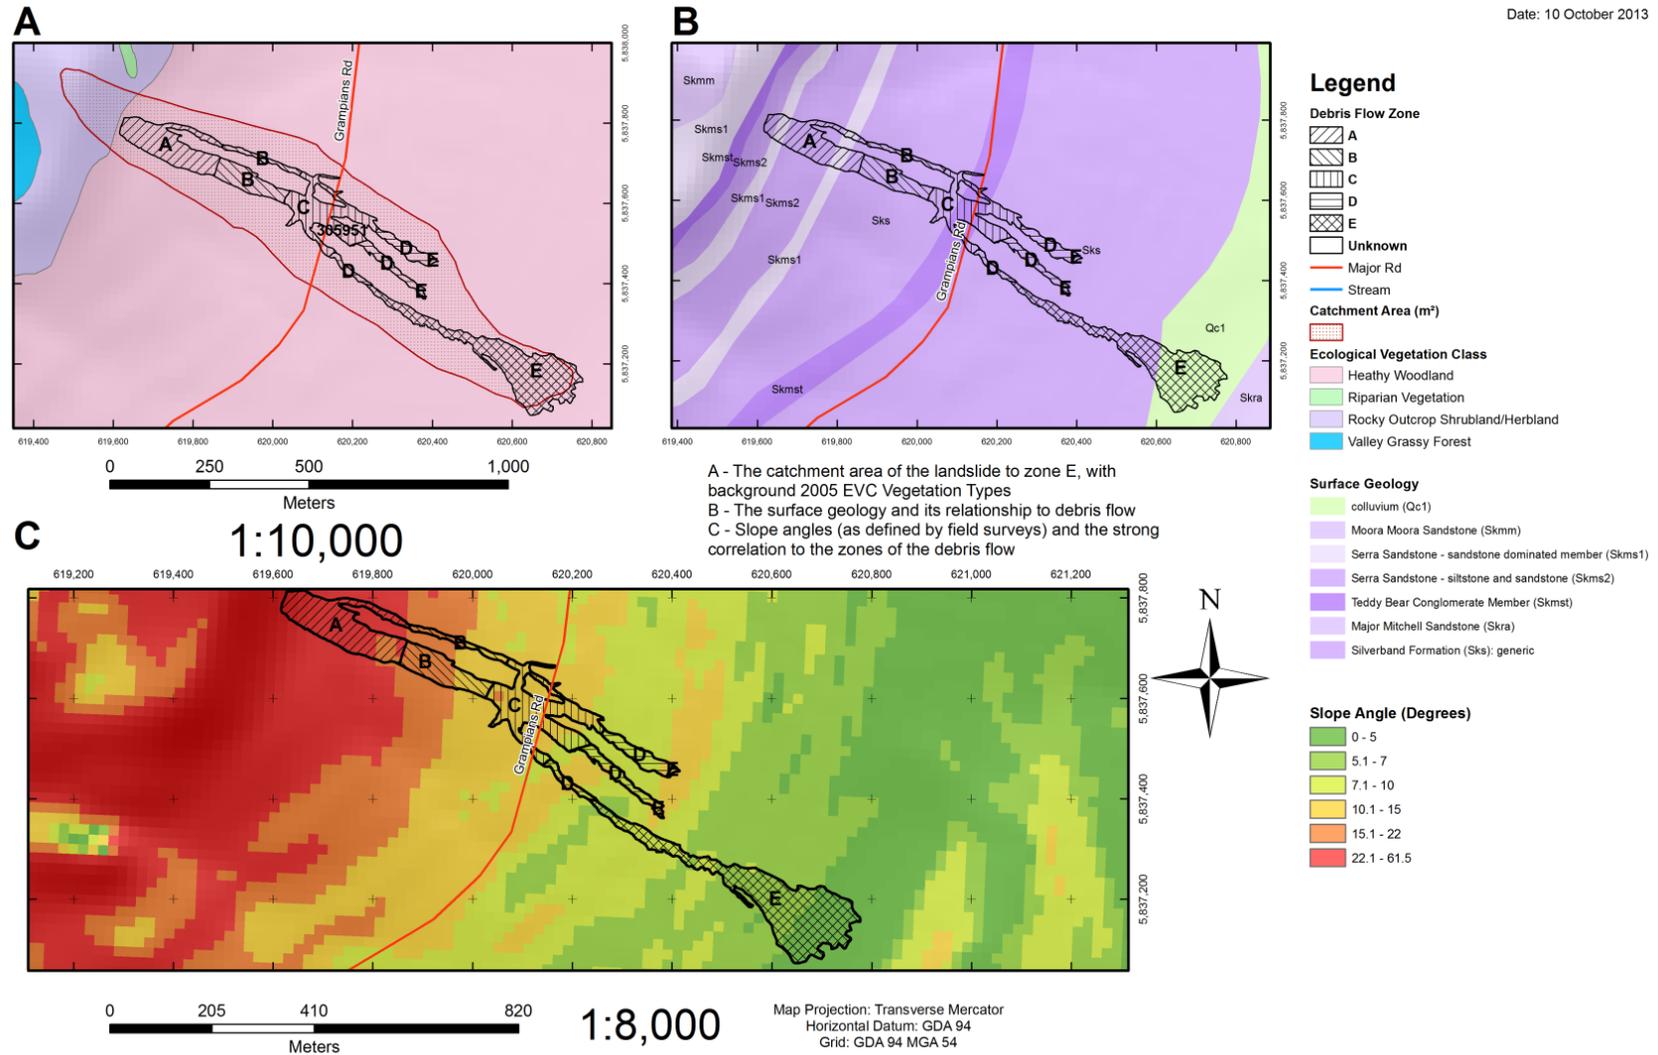
Figure 5.204

A - The catchment area of the landslide to zone E, with background 2005 EVC Vegetation Types
B - The surface geology and its relationship to debris flow
C - Slope angles (as defined by field surveys) and the strong correlation to the zones of the debris flow

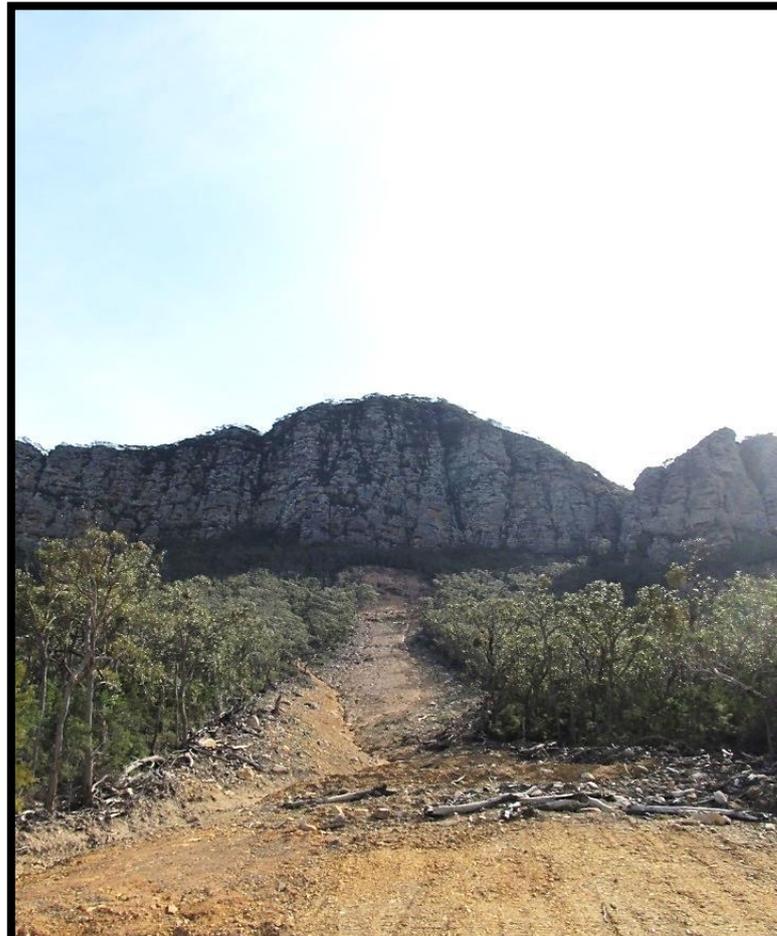
Figure 5.205 Looking upslope from the South Grampians Road (Zones A,B and the uppermost C) variable deposition of debris and vegetation.

Zone B – This zone is only differentiated from the previous zone by a change in slope angle to 15° and the presence of more vegetation debris to the margins of the slide as well as some initial boulder ($\geq 200\text{mm}$) deposition, Figure 5.205.

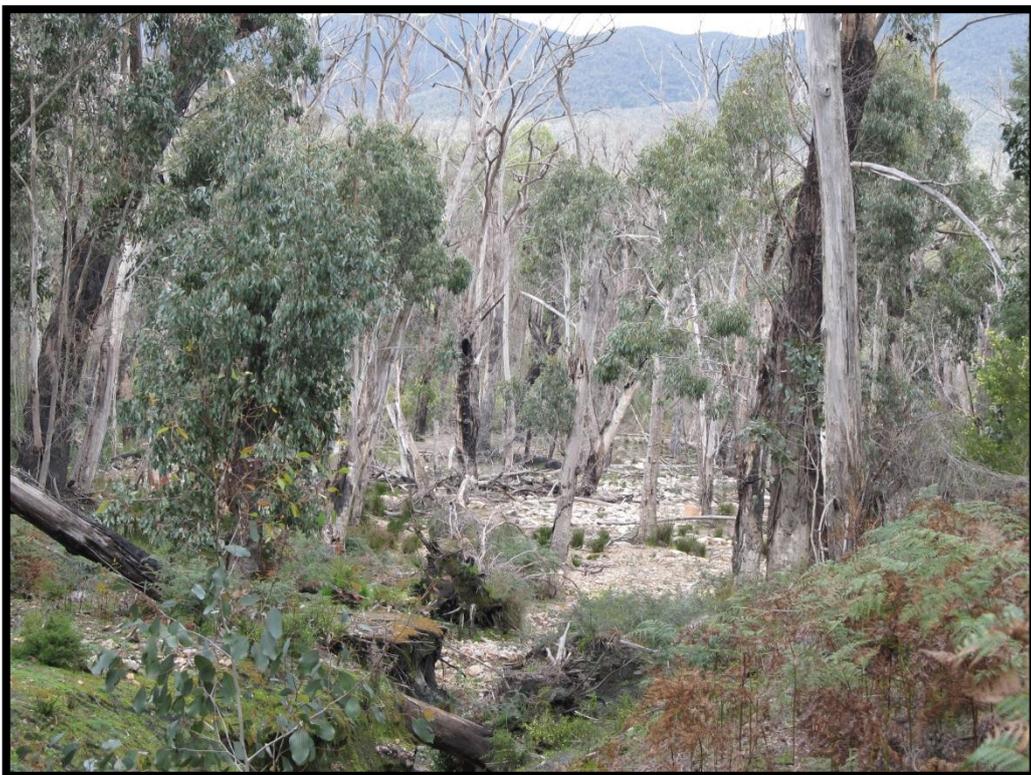
Figure 5.208 Photo of the transition from Zone C to Zone D. Note the sandy loam soil at the termination of slope.

Zone D – A major difference is marked by this zone as the slope all but terminates in this area where it meets an alluvial flood plain of Fyans Creek (Figure 5.208). The edge of the slope has a far greater loamy texture than sandy debris as is further up the slope. The slope angle rapidly changes from 8° to less than 5° where most of the sediment appears to drop out. The large fragments greater the 10 cm gradually peter out on the alluvial flats where there are dead trees in the photo.

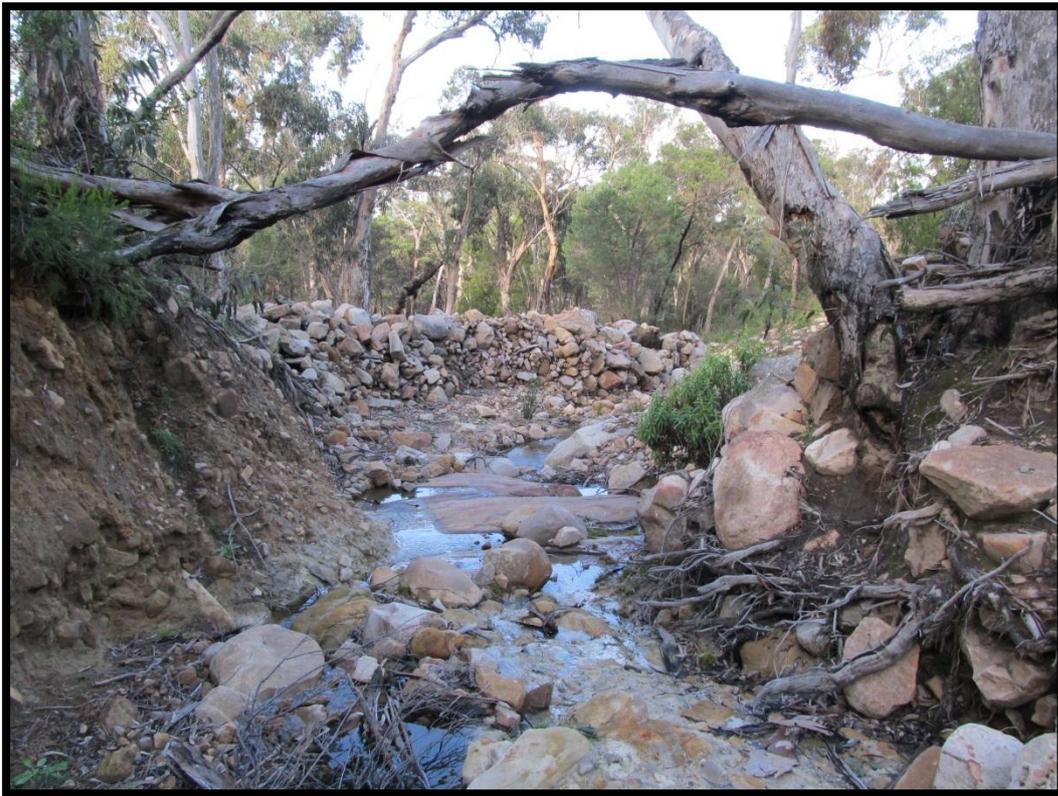
Figure 5.210 An example of rock fragments banking up and creating an obstacle, changing the course of the flow.

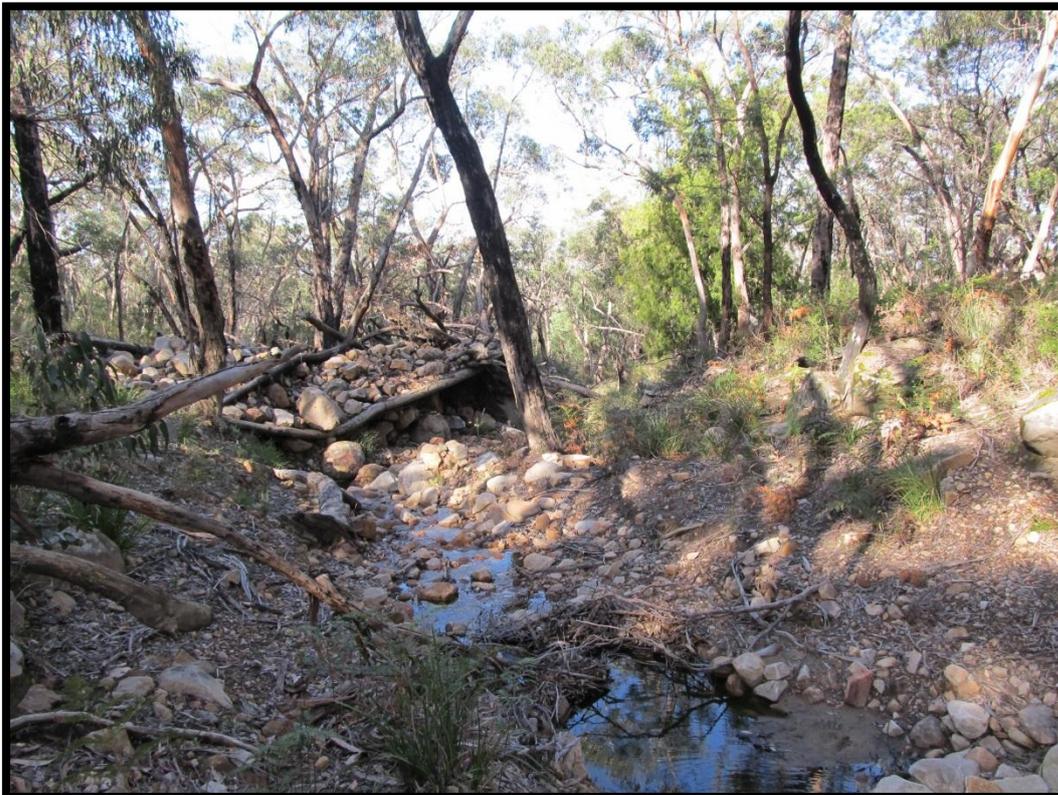
Figure 5.211 An example of rock and tree debris damming the flow path.

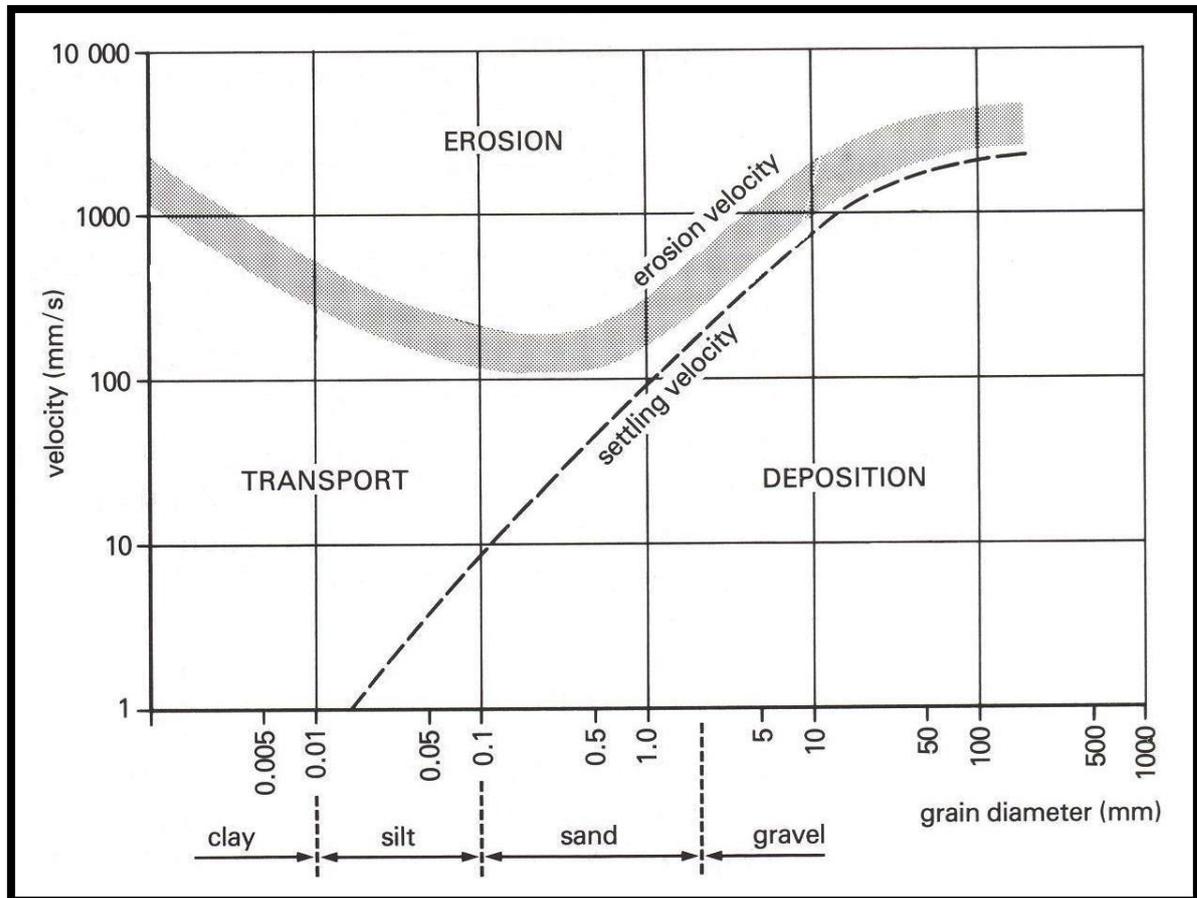
Figure 6.1 The Hjulstrøm Diagram (Geography-is-easy, 2013).

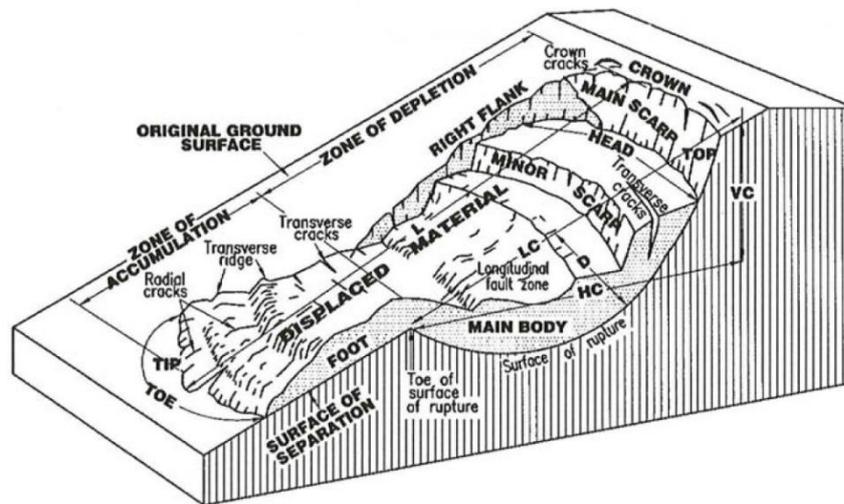
Figure A: Varnes (1978) diagram displaying typical landslide forms.

Nomenclature	
MAIN SCARP	A steep surface on the undisturbed ground around the periphery of the slide, caused by the movement of slide material away from undisturbed ground. The projection of the scarp surface under the displaced material becomes the surface of rupture.
MINOR SCARP	A steep surface on the displaced material produced by differential movements within the sliding mass.
HEAD	The upper parts of the slide material along the contact between the displaced material and the main scarp.
TOP	The highest point of contact between the displaced material and the main scarp.
TOE OF SURFACE OF RUPTURE	The intersection between the lower part of the surface of rupture and the original ground surface.
TOE	the margin of displaced material most distant from the top of the slide.
TIP	The point on the toe most distant from the top of the slide.
FOOT	That portion of the displaced material that lies downslope from the toe of the surface of rupture.
